**Technical Service
Information Bulletin**

**TRUNK PARTITION NET STRAP TOO
SHORT FOR VERTICAL INSTALLATION**

'07 LS 460/460L

BODY
BO001-07

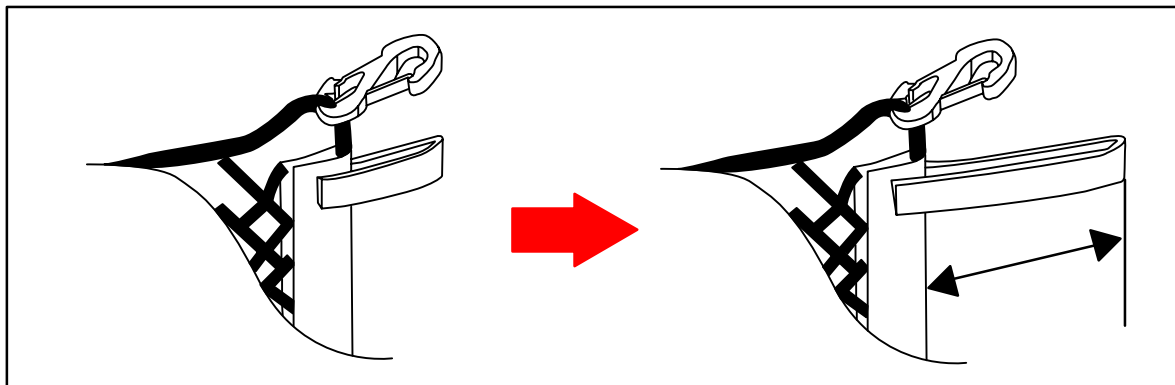
Introduction Some 2007 model year LS 460/460L vehicle customers may complain that the trunk partition net strap is too short for vertical installation.

The trunk partition net has been improved for this condition. Use the procedure below to correct this concern.

Order and replace the trunk partition net. Follow the installation instructions in the package to install the NEW partition net.
