**Technical Service  
Information Bulletin**

**RATTLE NOISE FROM ENGINE UNDER  
COVER NO. 2**

'07 LS 460/460L

NVH  
NV002-07

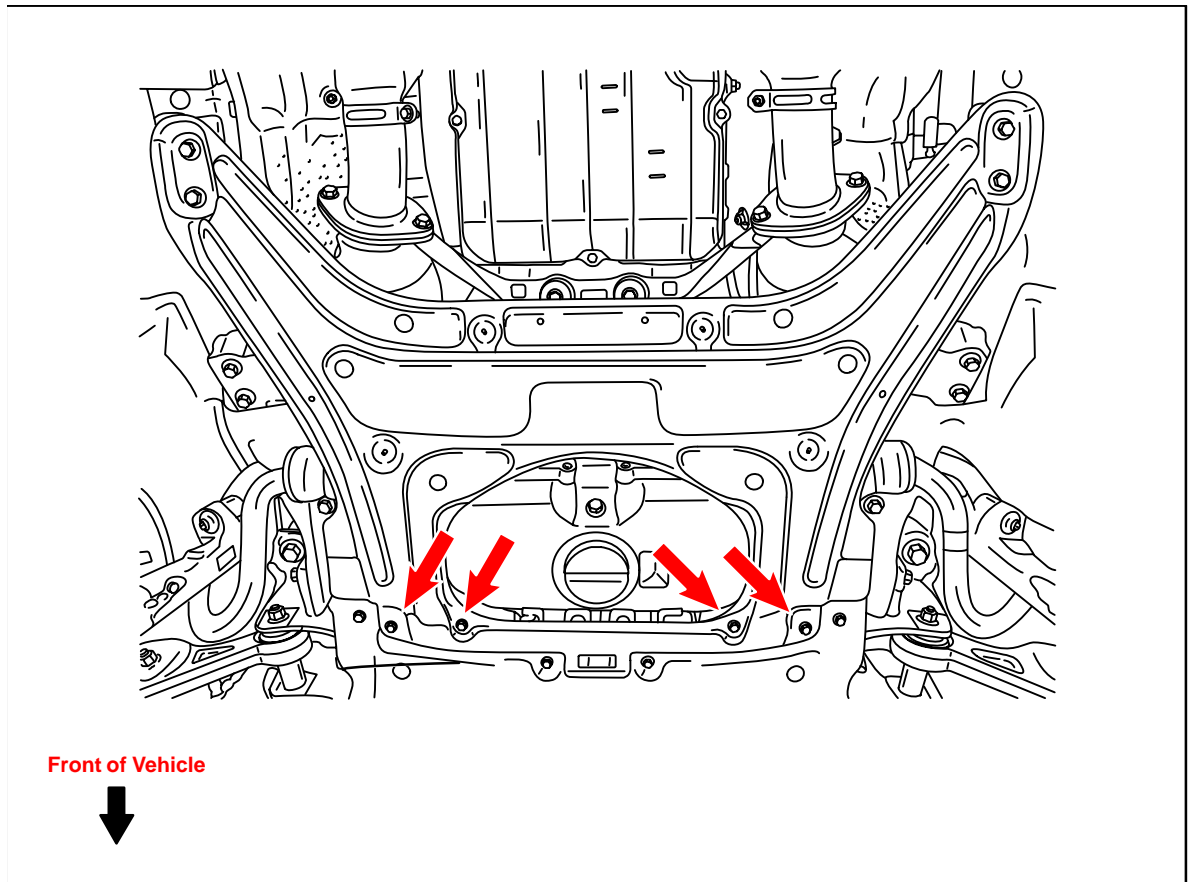
**Introduction** Some 2007 model year LS 460/460L vehicle customers may complain of a rattle noise coming from under the front of the vehicle. The noise may be caused by loose front bolts for the engine under cover No. 2. The engine under cover No. 2 is the large aluminum panel under the engine and transmission.

If any of the 4 front bolts are loose, tighten the bolts to the specified torque.

**Bolt head size: 10.0 mm (0.4 in.)**

**Torque:10.0 N•m (102.0 kgf•cm, 7.4 ft•lbf)**
